Attachment 8c
Hydraulic and Bank Migration of Minor
Detailed and Detailed Crossings Report

Project: Alaska Stand Alone Pipeline/ASAP		Project No:	138575
To:	Frank Richards	Deliverable No.:	002-14-916-008
From:	Mark McBroom	Document No.:	002-C-27-RTA-C-0019
[Internal MBJ]:	Shawn Snisarenko	Date Submitted:	10/10/2014
Subject: 2014 Waterways Field Program Summary: Detailed Crossings

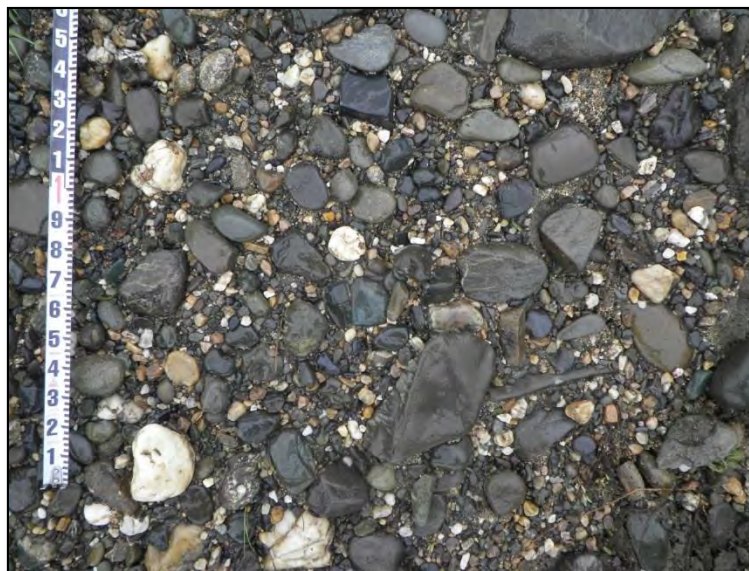
Photo 1 Bed Material Deposited on Bar of Main Channel of South Fork Koyukuk River (ST_261.9)

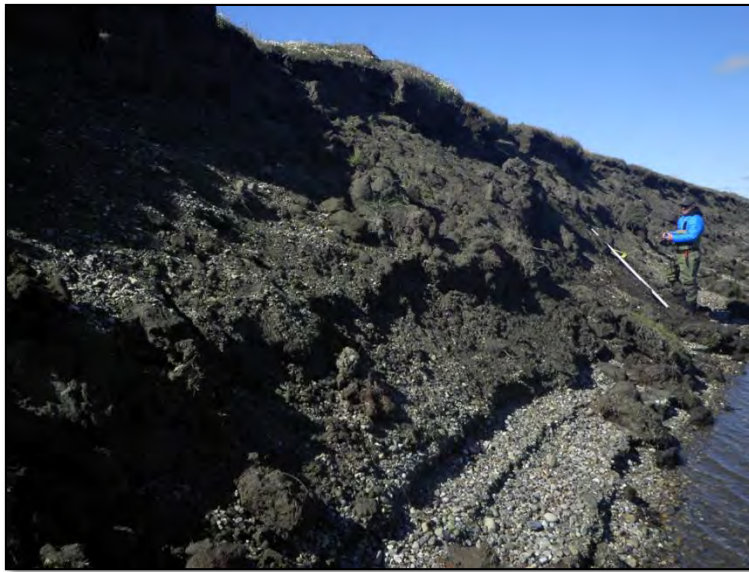
If erosion control design was deemed necessary the general extent of control measures was identified. Digital photos were captured to support and supplement Channel Migration Assessment data. Photo 6 shows the eroding right bank of the Putuligayuk River (ST_3.1).

Photo 6 Eroding Right Bank of the Putuligayuk River (ST_3.1) Looking Upstream
